Date: February 16, 2005

Subject: Shadowfax Run Subdivision
Jackson Avenue, New Windsor

Reference: January 14th flood conditions
In area of road

Memo by: Drew Kartiganer for
Shadowfax Run and
Tiger Lilly Development

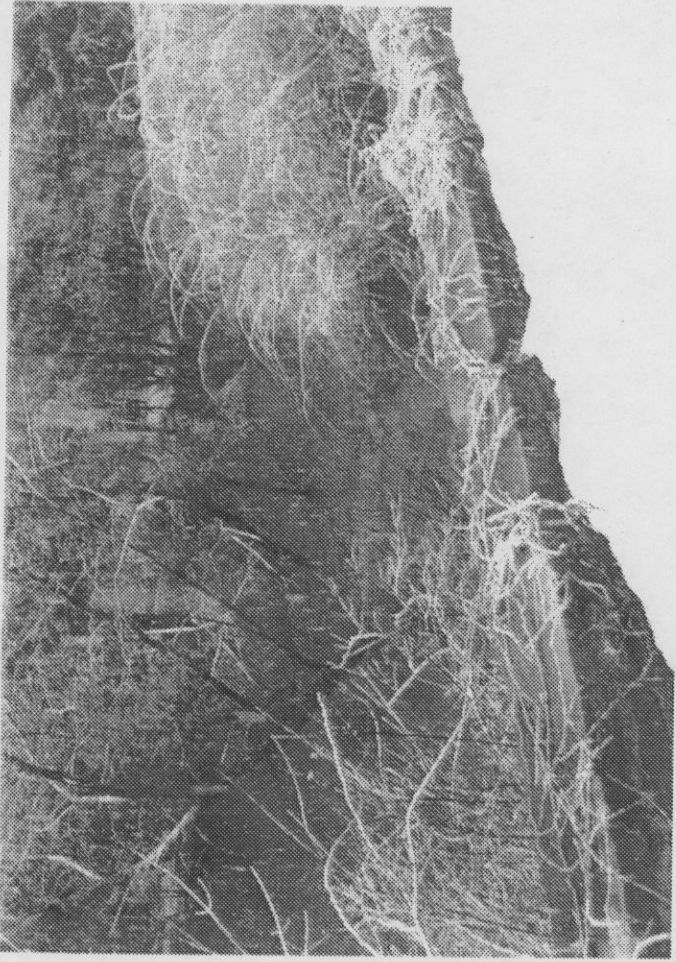
A /

A,B, are back water on east side of bridge (development side)

These Photographs were taken at the bridge near the top of Shadowfax Development site along Jackson Ave and show the "back water" conditions on the east side of the bridge and full water flow on the west side. The backwater condition on the east side of the road demonstrates that there is not sufficient release of water at the Bridge area to accommodate storm water release from the drainage basin that feeds this stream bed above the bridge.

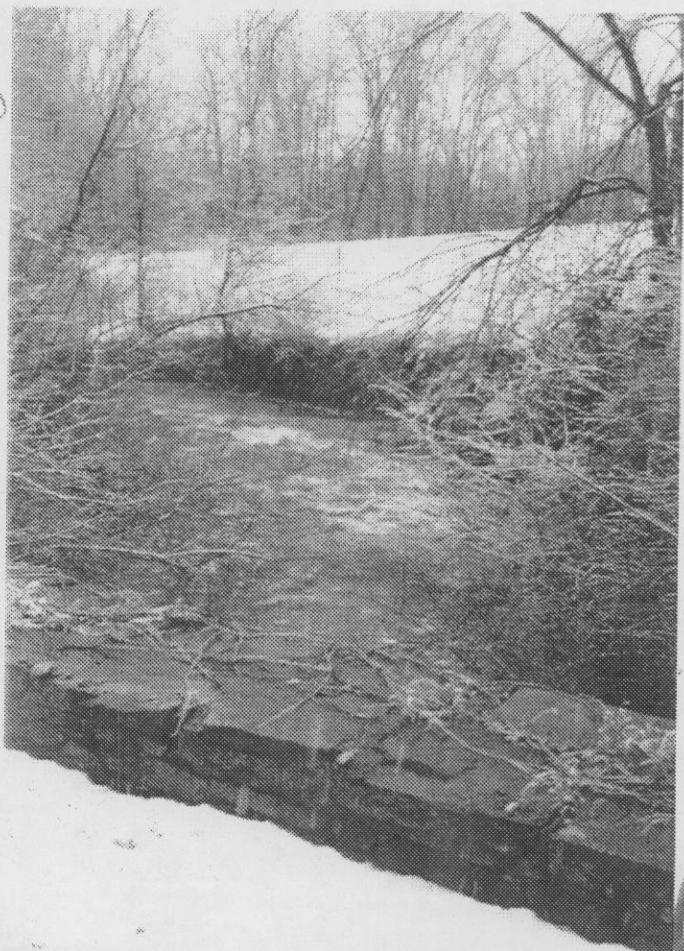
C

C,D are flow waters on west side of bridge
